Testing a new method for VIP interior insulation for heritage buildings

Stefan Bichlmair¹
Martin Krus¹
Ralf Kilian¹

¹Fraunhofer Institute for Building Physics IBP Holzkirchen

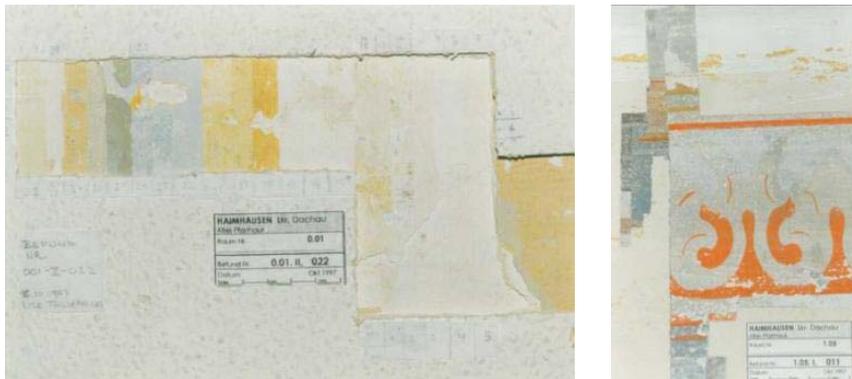
FIG 1: Exposed historic paint layers of a rectory of the 16th century in Haimhausen in greater Munich (Picture: Klaus Klarner, conservator, Munich)

In the view of cultural heritage preservation a mostly comprehensive tradition of the historical building substance is aspired (Charta of Venice 1964). Also plasters or paint layers are informative about the ancient way of live and therefore worth to conserve. The use of typical adhesives based on cement with additional plastic additives may damage or destroy these near surface layers. Furthermore substances of the adhesive may migrate into deeper material layer. With this procedure an irreversible damage may occur to these layers. A good adhering system may destroy additionally the plaster if removed. One example of near surface layers in a historic building shows FIG 1. The exposed layers are documents of the historic of the building and give an impression of the taste of the epochs.

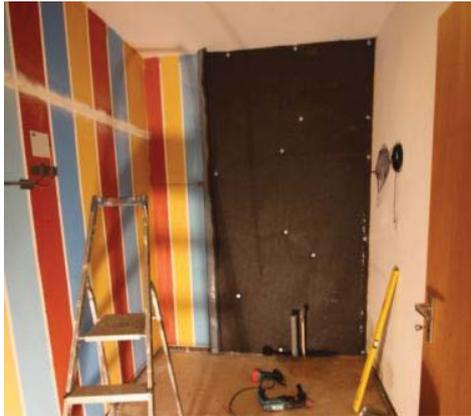
FIG 2. Interior view of the experimental building with the east and south walls with color swatches and some already mounted adhesive mat.

In a first step different adhesive matt systems that are available on the market, have been looked for and one of them is selected for use. Prior to installation, the construction was checked by calculation with the hygrothermal building simulation software WUFI® (Bichlmair et al 2012) developed by Fraunhofer IBP (Künzel 1994). The experiments took place in a building at the test site of the Fraunhofer IBP Holzkirchen. Here suitable test buildings, laboratories and workshops for the implementation of the project exist and also the required climate data for the site are known. FIG 2 shows the interior of the test building with test setup during mounting.

If the interior insulation is not fixed accurate backside air flows with infiltrated indoor air may occur and then mold growth is possible. For specific measurements of backside air flow, the application of adhesive mat is suitable, since a defined layer of air of approximately 1 cm is present in the mesh (FIG 2 and 3). To achieve a higher level of security against backside air flow in the adhesive mat special horizontal seal joint was formed dividing the masonry in three sectors. To implement this sealing without thermal bridging a double layer VIP system with ca. 10 cm thickness were used for this purpose, originally developed for exterior insulation (Kolbe 2012). To assess the impact of the seal joint on the original wall surface different sealing methods were developed. Four different systems were selected therefrom and applied (Bichlmair et al 2012). In addition, some specific open joints as a gap with ca. 1 mm width were produced to the adjacent bottom and ceiling as a reference for not tight seals to adjacent building parts. The test setup for measuring backside air flows was planned and carried out (Bichlmair et al 2012) with the homogenous tracer gas emission method (NTVVS 118, 1997) due to good experiences with this method in historic buildings (Kilian et al

The surface of the wall was painted with defined colors with different historical binders (FIG 2 and 4) to assess changes in consequence of the insulation (Bichlmair et al 2012). The color values were measured prior to mounting, using the standard method of CIELAB (EN ISO 11664, 2012). After removing the interior insulation, a further check on the original wall was made in order to assess the surface concerning degree of damage-freeness and change of the color values. The measured color lightness and color space are shown in FIG 4 in the right graph. There are only small deviations of the two measurements before mounting of the internal insulation and after removing almost 6 month later.

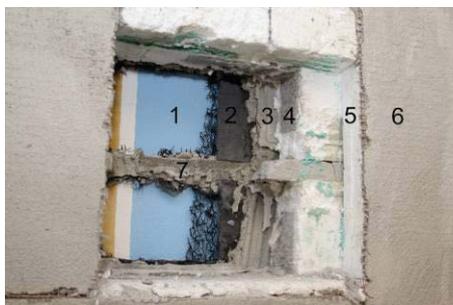
- 1 original wall surface
- 2 adhesive mat
- 3 adhesive mortar
- 4 VIP base element
- 5 VIP cover element
- 6 plaster
- 7 sealing

FIG 3. Component opening with layer indication of the interior insulation at the east wall.
