# Factors Determining Surface Moisture on External Walls

Hartwig M. Künzle, Dr-Ing

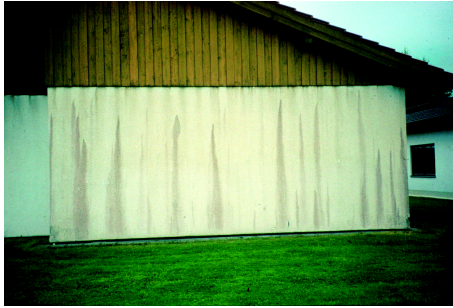
**Figure 1** *Growth pattern of algae on a west-facing wall caused by driving-rain exposure (“tiger pattern”).*

The driving-rain load on buildings has been studied extensively by many authors, most recently by Blocken (2004). A classification of driving-rain exposure of external walls can be found in *British Standard 8104, Assessing Exposure of Walls to Wind-Driven Rain* (BSI 1992). Whether an exposed façade is also prone to microbial growth depends on the duration as well as the intensity of the driving-rain spells and on the drying conditions between these spells. Figure 1 shows a typical microbial growth pattern on a wall caused by wind-driven rain. The vertical stripes result from run-off water carrying dirt or spores from the top of the wall, which usually sees the highest load, down to the bottom. Microbial growth caused by driving rain is a real challenge. One solution is to add biocides (chemicals that kill algae and fungi). To be effective, they have to be ingested by the living organism. This is only possible when the substance is slightly soluble, which means that the biocides will be washed out by rainwater

running down the façade. Therefore, adding biocides will only temporarily solve the problem.

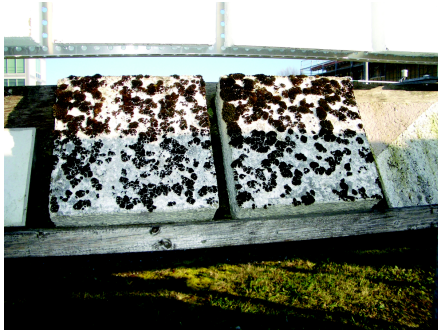
**Figure 2** Moss growing on EIFS samples exposed to the main driving-rain, orientation at an angle of approximately 30° against the vertical.

While a roof overhang can reduce the driving-rain load of the façade, a slight tilt of the wall may increase it. This is a rather severe problem for heritage buildings with skew envelope parts or modern architecture with deliberately inclined façades. Figure 2 illustrates the high moisture load by the intense growth of moss on EIFS samples exposed at an angle of approximately 30° against the vertical axis. While it is obvious that such a slope greatly raises the precipitation-catch ratio of the surface, in real life an increase in moisture problems can already be observed at very small inclinations. Therefore, the following tests have been carried out at the building field-test site in Holzkirchen to investigate this phenomenon.

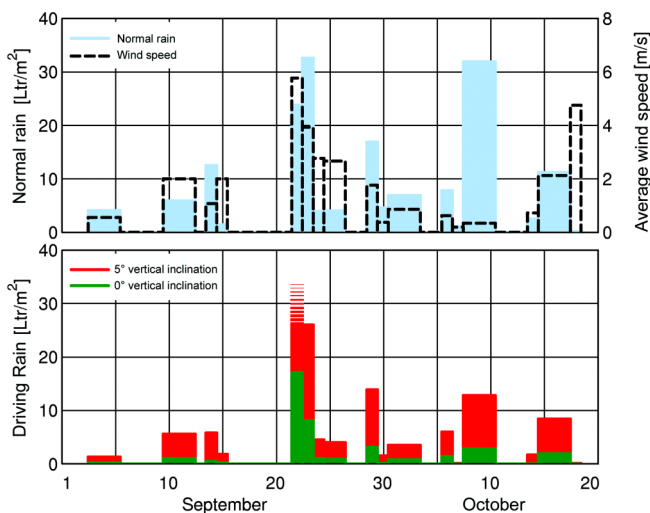
**Figure 3** Normal rain load and west wind speed recorded at a weather station nearby (top) and driving-rain load measured by driving rain gauges, with and without a 5° tilt, placed in the middle of a west-facing wall. Loads are displayed as daily res. three-day (weekend) sums.

Supplementing the continuous recording of wind-driven rain hitting the middle of a four-meter high west wall, an additional driving-rain gauge has been installed into the wall at the same height as the standard driving-rain gauge. The additional rain gauge was, however, slightly tilted (5°) with the lower end of the catch opening protruding approximately some centimeters out of the vertical plane of the façade boundary. The recorded catch ratios of both driving-rain gauges are presented for a period of two months in autumn at the bottom of Figure 3. The normal rain load (recorded with a horizontal rain gauge at the meteorological station nearby) and the average wind speed (west direction only) are indicated above. Compared to the vertical driving-rain gauge, the 5° tilt increases the catch ratio by approximately a factor of four. Even during moderate winds (5 m/s), it may almost reach the amount of normal rain. This is much more than theoretically expected (e.g., resulting from vector calculation), but it could explain the moisture problems occurring at inclined façades in practice.

There is one possible explanation for this phenomenon. The tilted driving-rain gauge collects not only the wind-driven rain hitting the façade plus a small portion of normal rain. It also collects rainwater that splashes back from the façade areas above the gauge. According to Künzel (1995), approxi-

mately 70% of the driving rain hitting the façade stays there; the rest splashes off the surface and falls to the ground. Since the horizontal component of the wind speed approaches zero close to the façade surface, it is unlikely that the splash-back water is driven back to the façade, because it will never regain the momentum of the original rain drops. Therefore, these splash-water drops will fall to the ground forming a sort of water-droplet curtain. Any protruding façade component reaching into this droplet curtain—such as the tilted driving rain gauge—will thus catch a considerable amount of splash water. If the wall area above the protruding façade component is large enough, the effective driving-rain load (including splash water) may exceed the normal rain load. For this reason, protruding or inclined façade components need a special rain protection similar to those used for roofing.

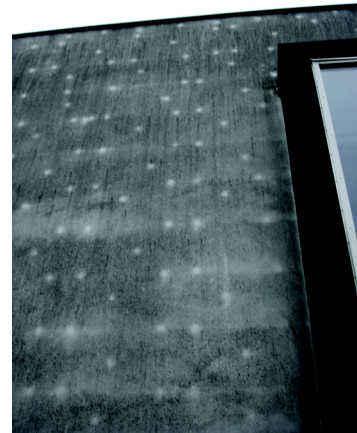
**Figure 4** Typical pattern (in Europe often called “leopard pattern”) caused by the formation of fungi or algae on EIFS as a result of exterior condensation.

Exterior condensation on a wall surface occurs when its surface temperature drops below the dew point of the ambient air. As already described in previous papers (Künzel and Sedlbauer 2001; Holm et al. 2004), the main reason for this temperature drop is the long-wave radiation exchange of the façade with the atmosphere, which results in a net heat flux to the sky (i.e., heat energy sink) when the sun is down or low. If the wall is a massive structure with a high thermal inertia (capacity to retard temperature changes due to a high mass), the night-time radiation sink is usually not strong enough to bring the surface temperature below the dew point for a significant period of time. However, modern exterior insulation finish systems (EIFS) don't have much thermal inertia and are subject to considerable amounts of exterior condensation (Nady et al. 1997; Künzel and Sedlbauer 2001). The photograph of a building with an EIFS in Figure 4 shows the typical spotted pattern caused by microbial growth due to exterior condensation. The bright spots indicate the position of the fasteners holding the system in place. They act as point-like thermal bridges keeping the surface temperature in a small circle above the dew point. Thus, microbial growth may help to detect all kinds of thermal bridges in wall structures.

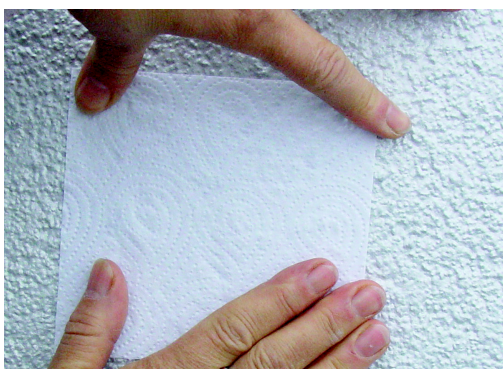
**Figure 5** Determination of the amount of surface water on a test façade with EIFS by using a special blotting paper whose mass change is being determined.

(water droplets) in order to start microbial growth, it certainly speeds up the sporulation and growth process. Therefore, the surface wetness (amount of surface water) is a critical quantity for the probability assessment of microbial growth. Over the past ten years, several techniques have been investigated to determine the surface water content, such as infrared reflectance and electrical resistance of the surface. However, our own experience shows that the most reliable method to quantify the surface wetness is also the simplest. A blotting paper with well-defined size and properties is weighed before and after close contact with the exterior wall surface (Figure 5).

In order to determine the response of the exposed wall sections to the natural moisture loads, blotting-paper tests were conducted when the presence of surface water was expected (Figure 5). The first readings of surface wetness in Figure 6 were taken during the morning hours of a rainy day (light wind-driven rain). The amount of water extracted from the three coatings differs significantly. While the mineral silicate paint and the nanostructured paint stay almost dry, the

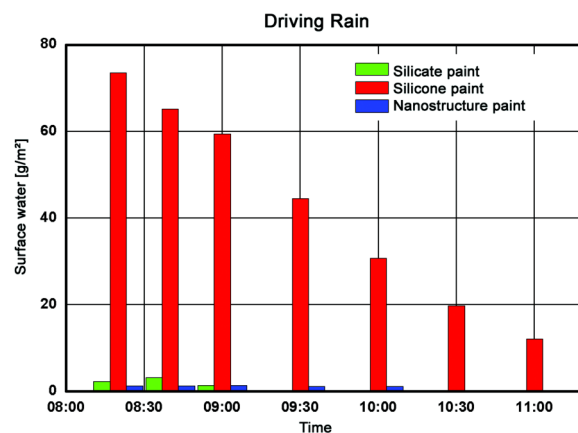
**Figure 6** Surface water extracted from a test façade with EIFS during and after a rain period in the morning hours.

surface wetness of the silicone paint is rather high in the beginning, slowly drying as the rain stops. The silicate paint, having the highest water absorption coefficient of the three coats investigated, lets some rainwater penetrate into the stucco, which could explain why there isn't much water on its surface. However, this cannot be the explanation for the lack of surface moisture on the nanostructured paint. Since it has the lowest  $A$ -value, the amount of surface water should be the highest.

nanostructured paint during driving-rain events (Figure 6). The rainwater does not cling to the surface but immediately runs off to the ground.

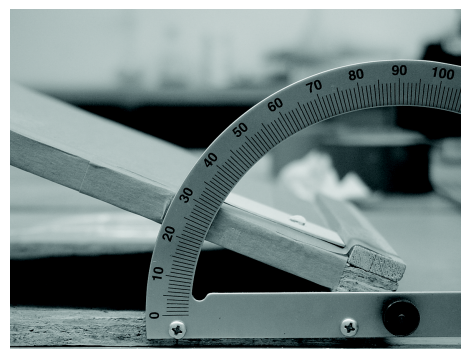
**Figure 7** Sloped plane device to determine the run-off angle of standard-size water droplets on paint.

For a better understanding of this phenomenon, the droplet run-off angle of the coatings had to be determined. This has been done in the laboratory with the coatings applied to a sloped plane (Figure 7). In the beginning, the run-off angle was about the same for all three paints ( $40^\circ$ – $46^\circ$ ). But after 24 months of exposure to natural weather, only the nanostructured paint retained its original run-off angle while the draining capacity of the other two paints deteriorated to a point where the droplets didn't even run off at the vertical position (run-off angle  $> 90^\circ$ ). This explains the performance of the

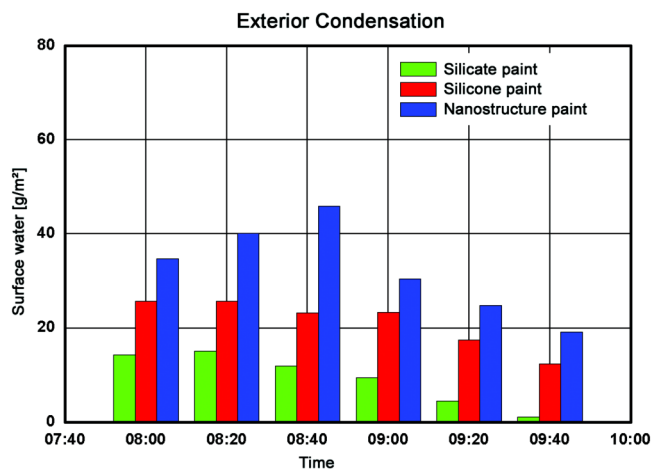
**Figure 8** Surface water extracted from a test façade with EIFS in the morning of a clear day.

The blotting-paper tests were repeated when exterior condensation instead of wind-driven rain was expected to be the cause of surface wetness. The readings in Figure 8 were taken during the morning hours of a day with a clear sky. The question as to why surface wetness is still increasing after sunrise will be addressed below. In comparison to the situation during a rainy day (Figure 6), there is a big difference regarding the behavior of the nanostructured paint. Instead of showing the best performance, as during the driving rain event, it now seems to show the worst, having the highest surface wetness. This is not really surprising when the respective water-absorption coefficients ( $A$ -values) are considered again. The coating with the smallest  $A$ -value, the nanostructured paint, shows the highest surface wetness because there is very little surface water penetration. Logically, the coating with the highest  $A$ -value—the mineral-silicate paint—retains the least amount of condensate on its surface, and the performance of the silicone based paint is somewhere in between. The load-dependent performance of the nanostructured paint must be due to the characteristics of the surface water. While the incoming rain droplets easily run off the structured surface, the water droplets forming when exterior condensation occurs seem to be different. They are either too small to be displaced by gravity or they get caught within the nanostructure somehow.

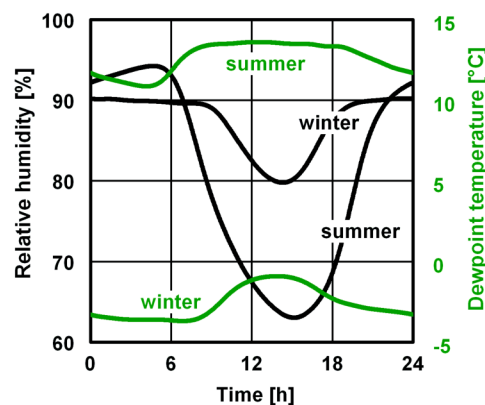
**Figure 9** Average daily cycles of RH and dew-point temperature at Holzkirchen in the summer and winter months.

In order to explain why the surface wetness of a west-oriented façade may still increase or even start to appear after sunrise, the temporal behavior of the ambient-air humidity has to be understood. For the location of the experiments (Holzkirchen), the seasonal averages of the daily cycles of the outdoor RH and the dew-point temperature are presented in Figure 9. While the RH falls after sunrise due to the increasing

outdoor air temperature, the dew-point temperature—a measure for the absolute humidity of the air—goes up. This effect has a similar magnitude in all seasons. It might be caused by dew evaporating from the ground or by fog dissolving. Since a west-oriented wall heats up very slowly in the morning, the rising dew-point temperature of the ambient air may lead to rather intense condensation on the cold façade. It is quite obvious that algae benefit from this phenomenon because there is moisture and light at the same time.
